Maryland Historical Trust State Historic Sites Inventory Form

1. Nam	(indicate p	referred name)		
historic ORIC	GINAL FARMHOUSE	OF ABERDEEN HILI	is .	
and/or common	"Thl. Col?	F.::Mhouse"		
2. Loca	ation			
street & number	318 Roberts V	Var		not for publication
city, town ABEI	<u> </u>	vicinity of	congressional district	
state MARYLA	AND	county	HARFORD

HA-1746 /739 COLE FARMHOUSE

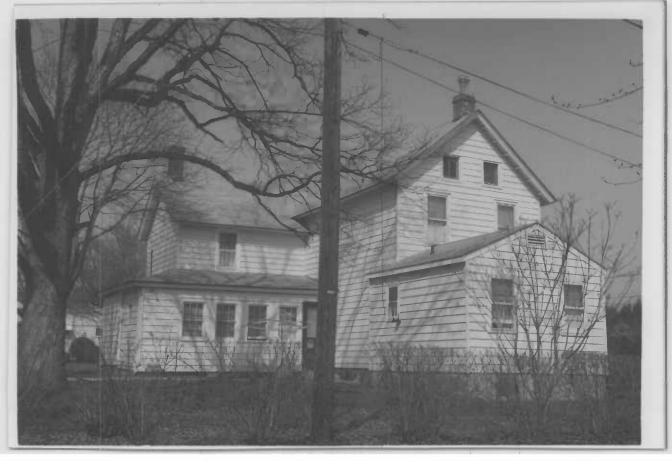
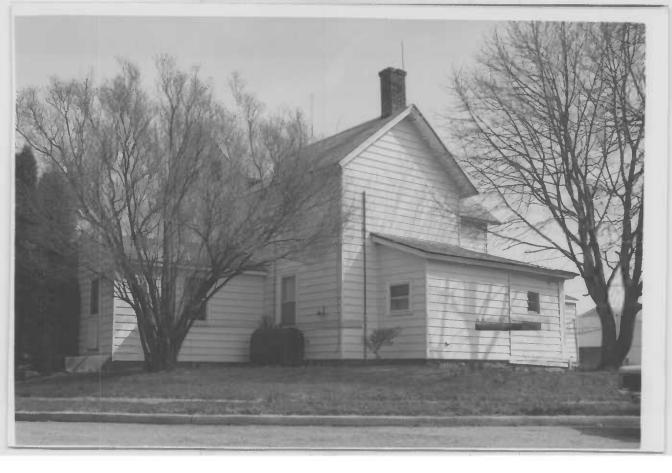
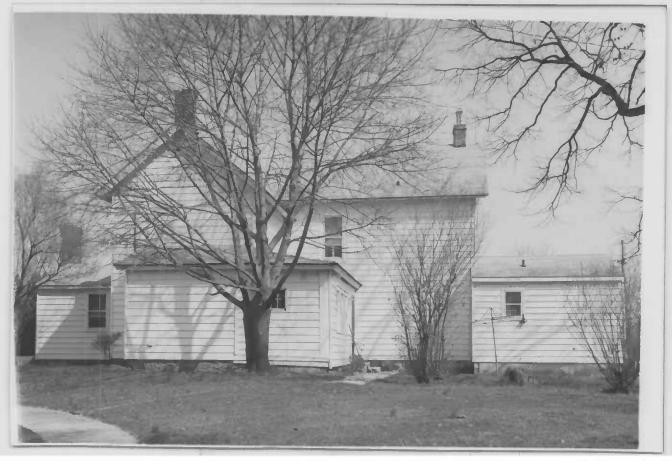
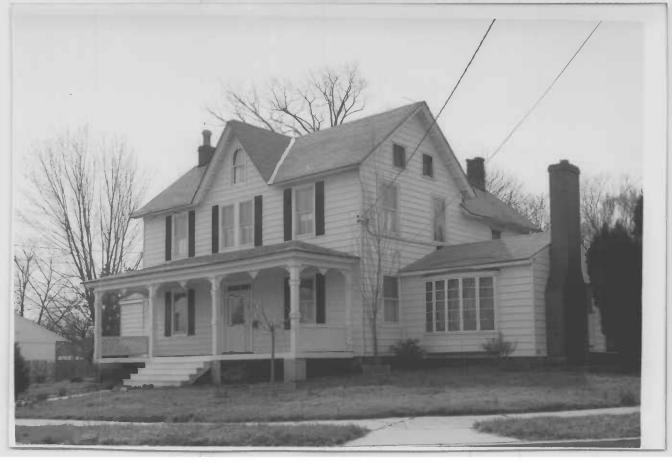
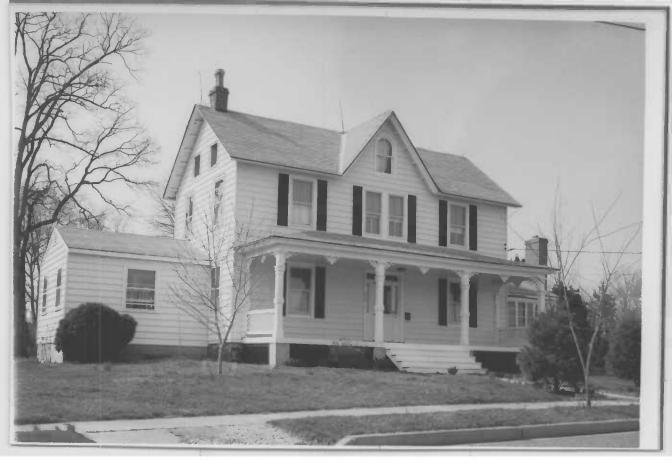
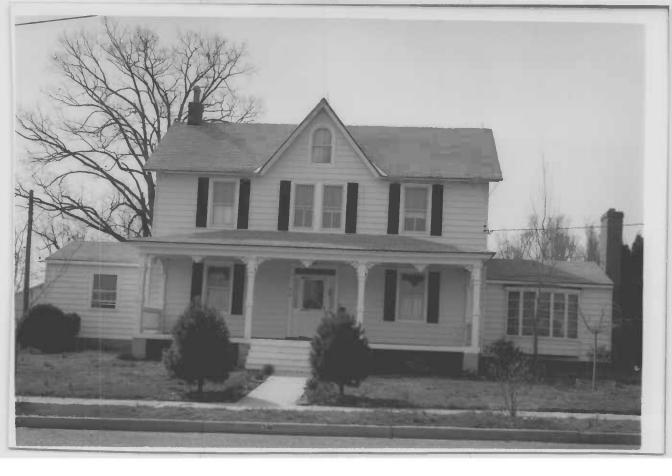
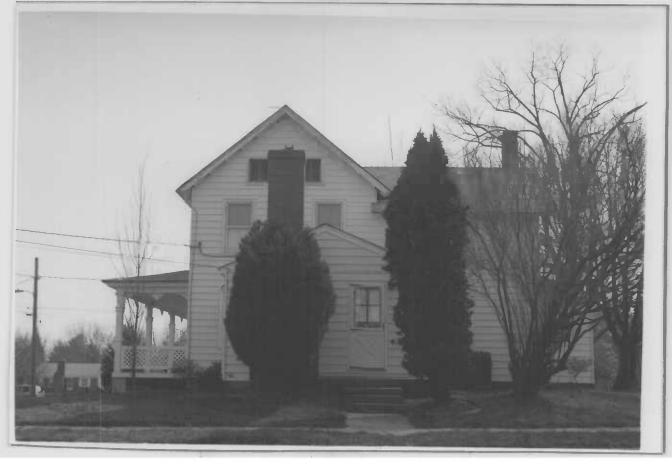
This is a three-story Victorian home, believed to be the original farmhouse of Aberdeen Hills at an age of over 100+ years. The following gives a description with supportive resources of our home:
